TBF/TBM Avenger

Walk Around Number 25
squadron/signal publications

By Lou Drendel

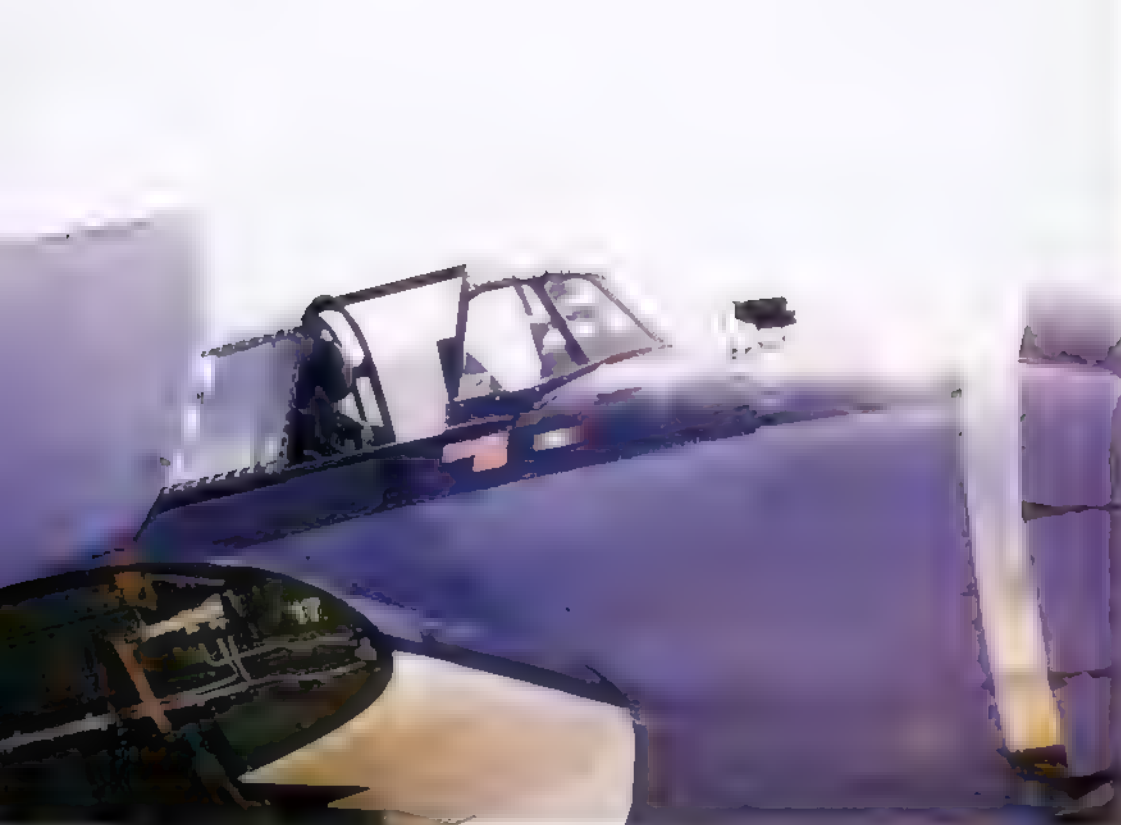
(Above Left) Late model TBM-3s were delivered without the Mark 11 ring and post gun-sight, which was fitted to previous Avenger models. The Mark 11 served as a manual back-up to the Mark 8 reflector gunsight installed aboard the aircraft. This particular restoration also lacks the Mark 8, which was the pilot's primary aiming device for the forward machine guns. An AN-N6 gun camera was placed in front of the windshield; TBF/TBM Avengers did not often carry this item. This restored TBM-3 was painted in an inaccurate camouflage scheme, with the area under the cowl flaps in polished metal instead of being painted to match the fuselage camouflage. Three Japanese 'rising sun' flags and two torpedoes were painted under the windshield, while the pilot's port and starboard canopy sections were slid back to the open position. (Lou Drendel)

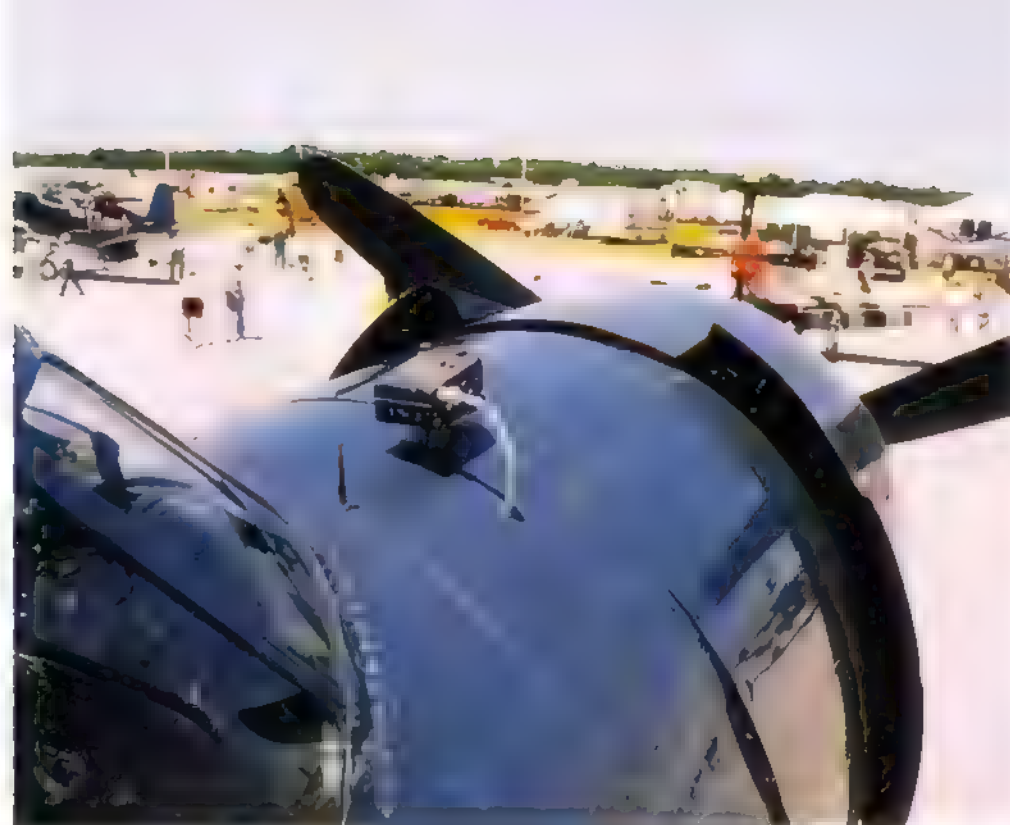
(Above) The cowl flaps were fully opened on this restored TBM-3 on display. The AN-A6 gun camera is mounted on top of the nose, aft of the cowling. The post of the Mark 11 ring and post sight is positioned behind the gun camera. The pilot lined up the bead on top of the post with the crosshairs of the ring directly behind the post to aim his machine guns at the target. The more advanced reflector gunsight – in which the aiming point was projected onto an angled glass screen for the pilot – provided the lead angle for a swiftly moving target. The Mark 8 and other reflector sights superseded the ring and post gunsight during World War II. (Lou Drendel)

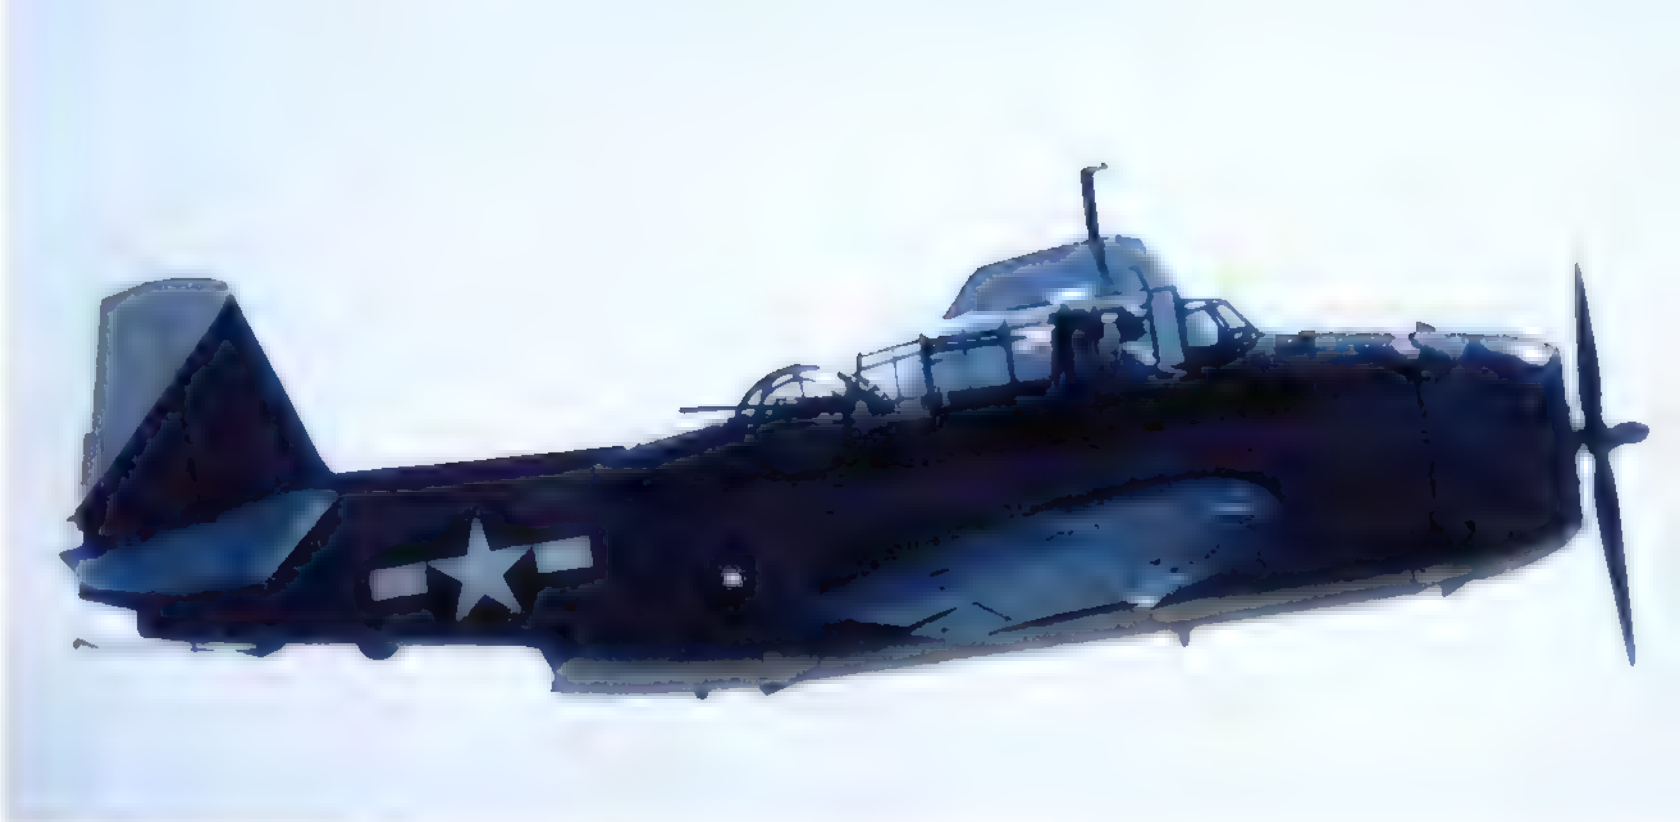
A restored TBM-3E flies over Chino, California on 17 May 1987. Late production TBM-3Es – beginning with BuNo 86175 – replaced the fully retractable tail hook of earlier Avengers with a non-retractable external tail hook. The ventral machine gun position was deleted and the cowl flaps were of equal size, with the bottom two flaps lacking the indentation found with earlier TBMs. The pilot of this aircraft partially opened his port and starboard sliding canopy hoods, which allowed fresh air into the cockpit. Many Avenger pilots – particularly those who flew TBD Devastators before and early in World War II – preferred to fly with the canopy open as much as possible. The canopy was opened for both launch and recovery to ease an emergency exit from the aircraft in the event of an accident. (Ted Carlson/Fotodynamics)

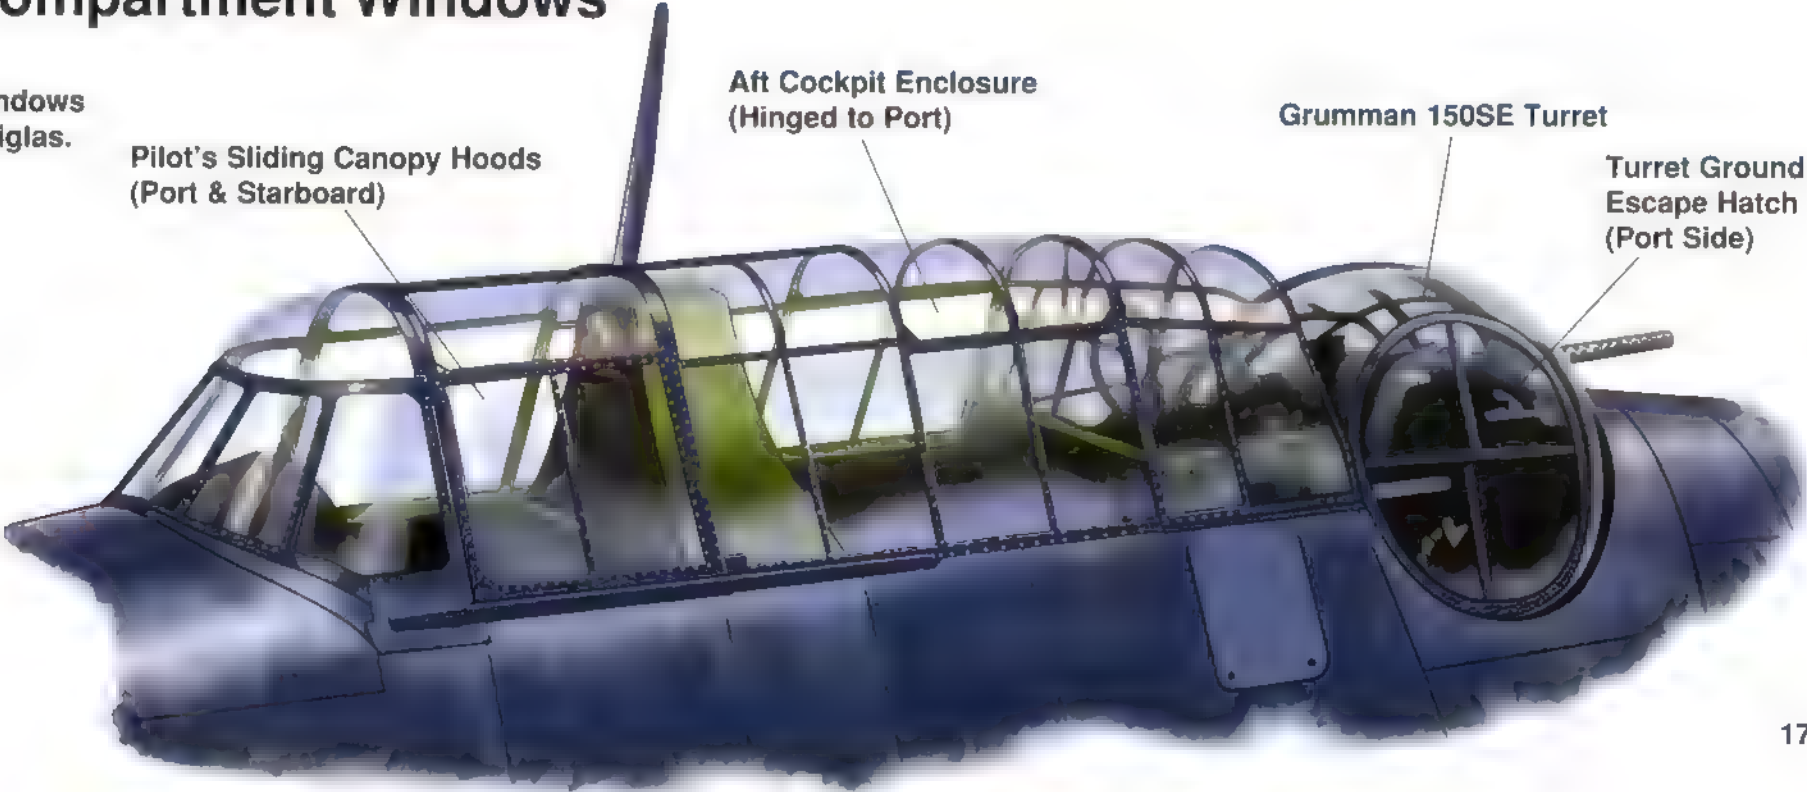
Flight Compartment Windows

All TBF/TBM windows made from Plexiglas.

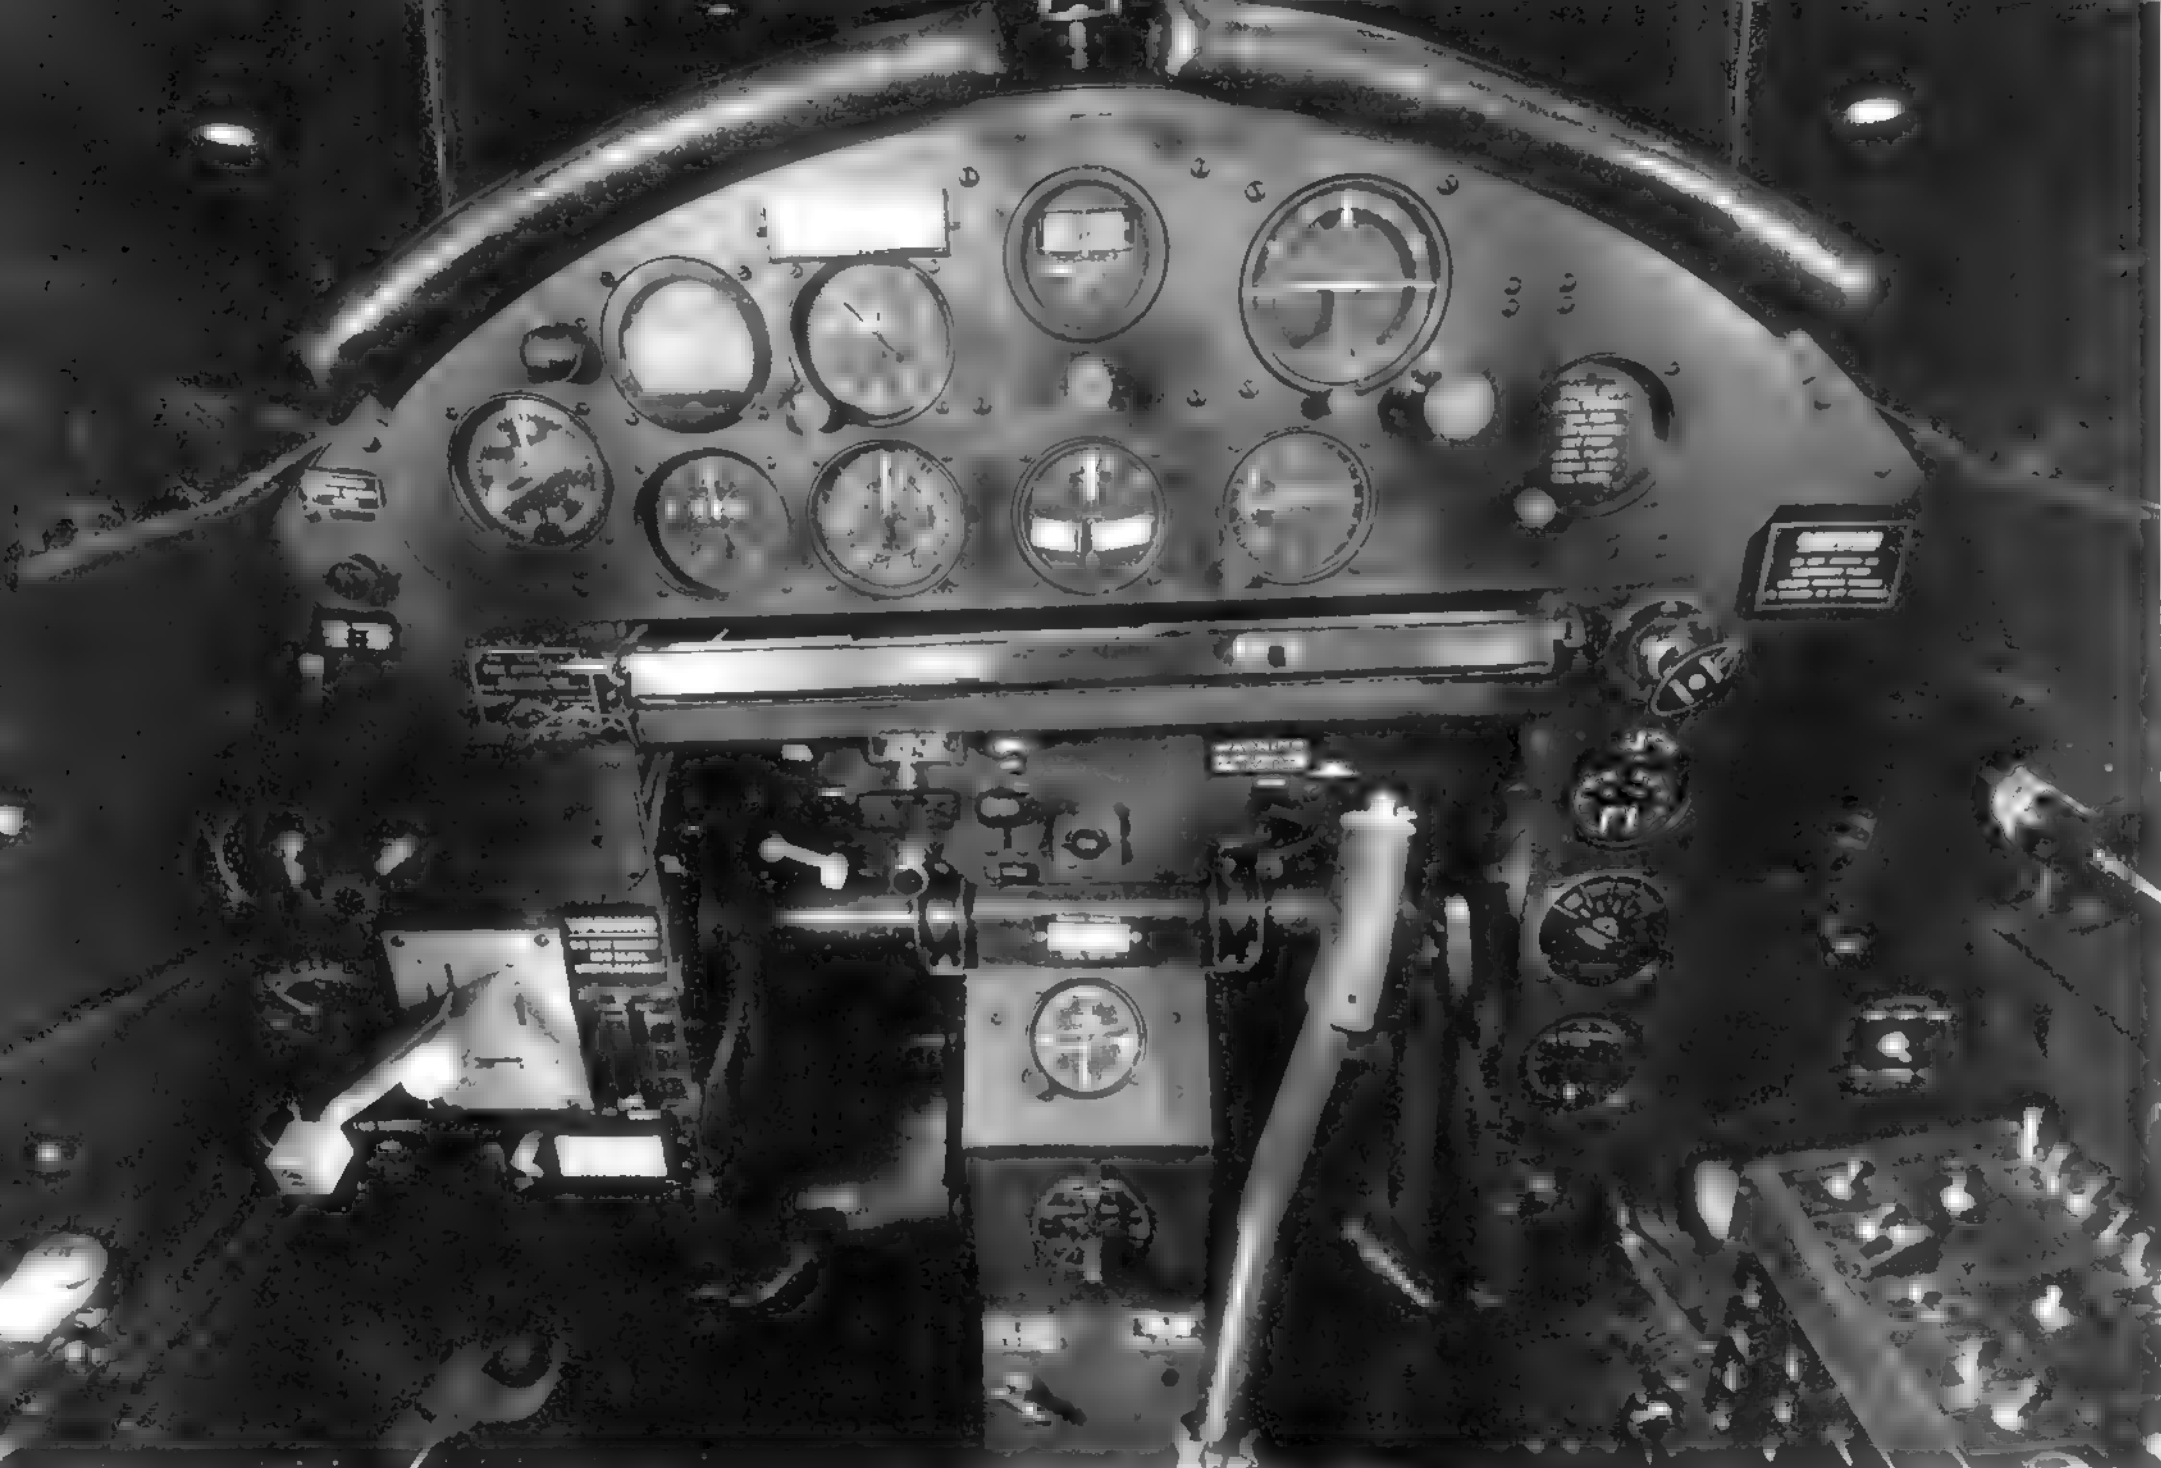
The TBF-1's instrument panel was topped by a padded leather-covered coaming. The top row of instruments consisted of (L-R): direction indicator, altimeter, directional gyro, and artificial horizon. The instruments arrayed below were: manifold pressure gage, tachometer, air speed indicator, turn and bank indicator, and rate of climb indicator. The pull out

plotting board used for navigation was located just under the instrument panel. The control stick was pulled to starboard, which allowed a clear view of the main instrument panel. The remote indicating compass was installed atop the center console, immediately ahead of the control stick's neutral position. (Grumman)

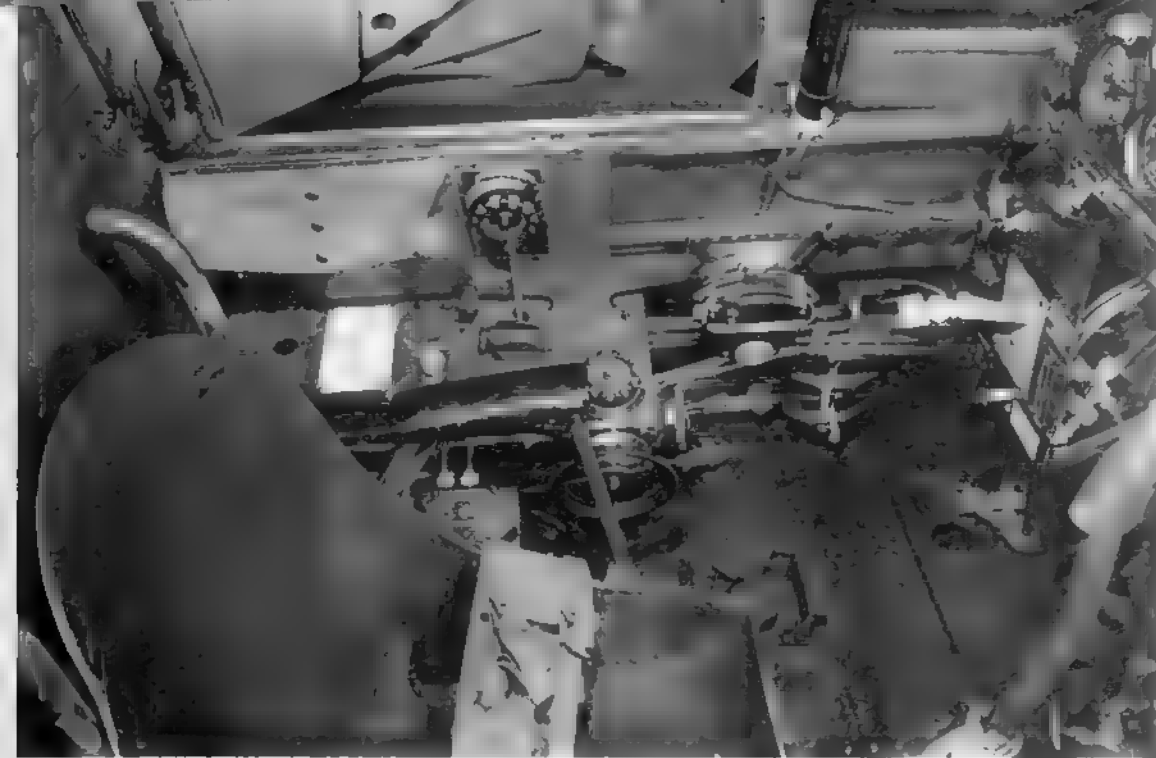
The flap and landing gear control levers were placed on the TBF-1's port instrument panel section. The throttle quadrant was placed aft of this panel under the canopy rail. The supercharger control was mounted outboard of the throttle. Rudder and elevator trim controls were behind the throttle quadrant, while the arresting gear (tail hook) control switch was located beside the pilot's seat edge. (Grumman)

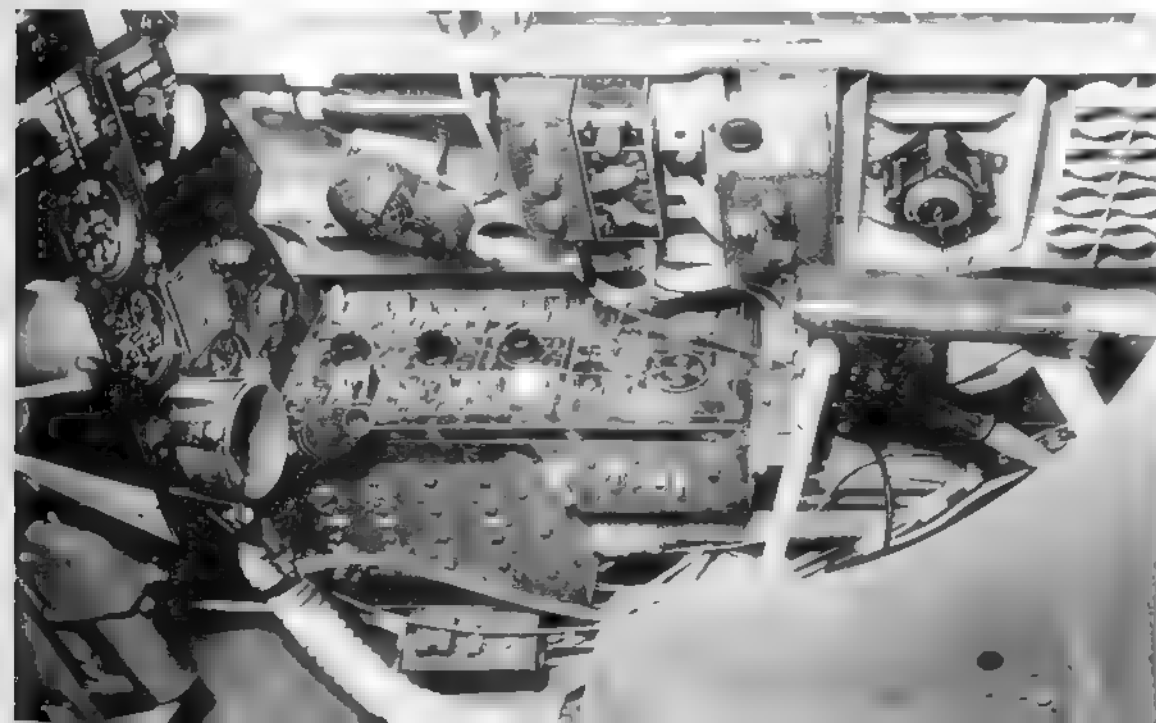
The electrical distribution panel was located immediately aft of the starboard instrument panel section. Radio controls were placed above and below the right side console. Above the seat armrest was the signal flare launcher, with racks for flares aft of this launcher. The pilot's seat had room to allow a parachute to be worn as a seat cushion. (Grumman)

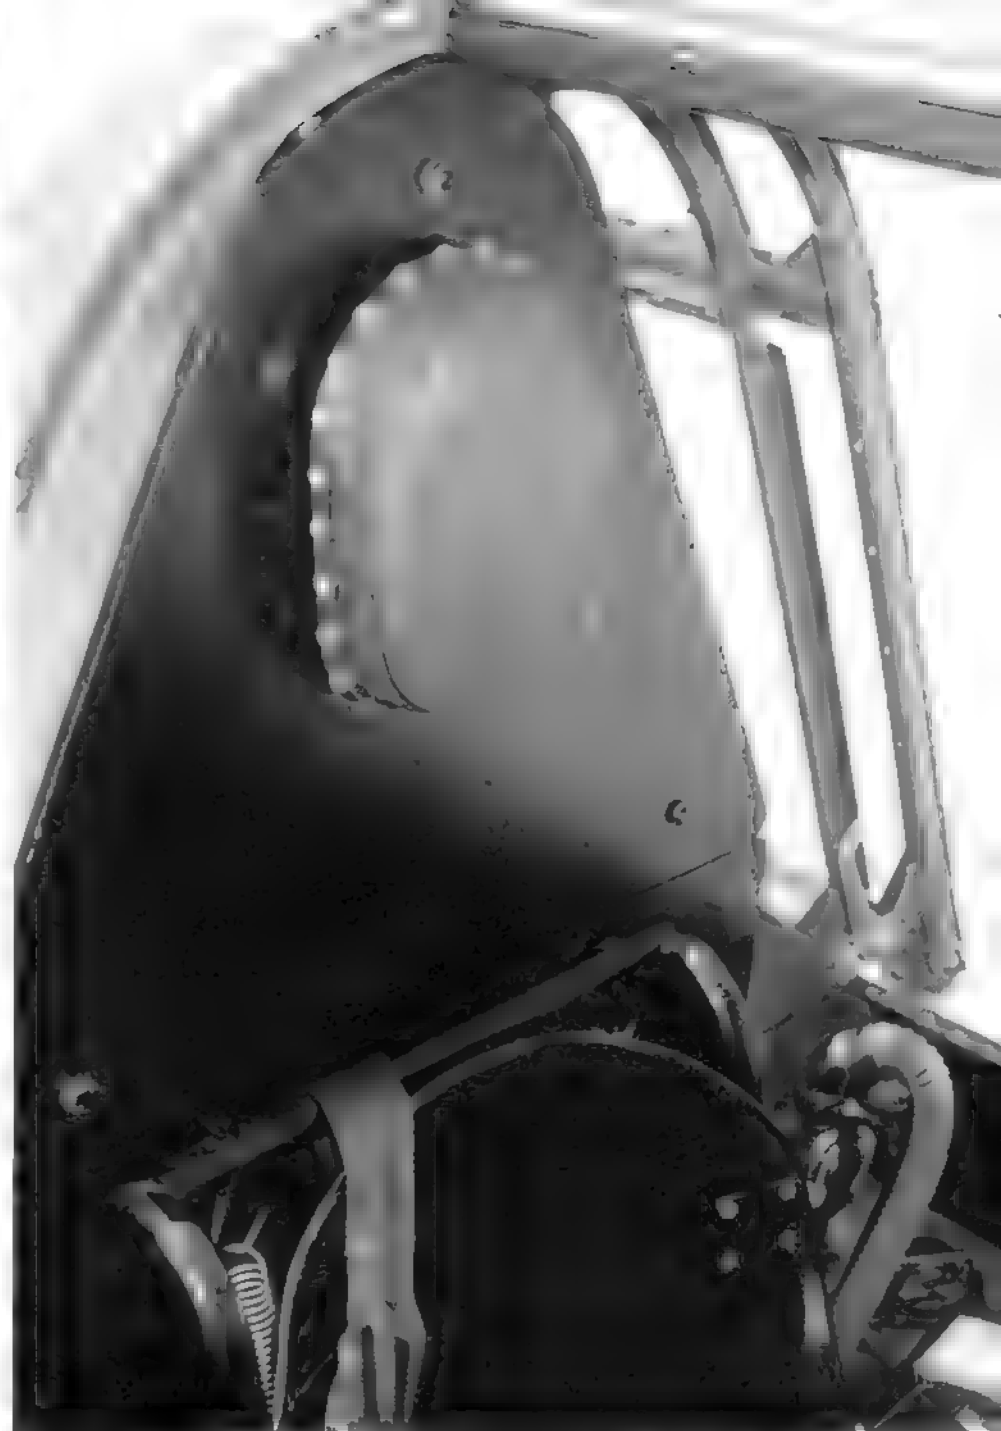
The TBM-3's seatback armor plate and padded headrest were the same in earlier Avenger models. The armor plate behind the pilot's seat was .375 inch (9.5mm) thick, while the armor supporting the headrest was .75 inch (19.1mm) thick. The TBM-3 pilot's seat height was adjusted using steel springs behind the seat, which replaced shock cords fitted to earlier Avenger models. (Lou Drendel)

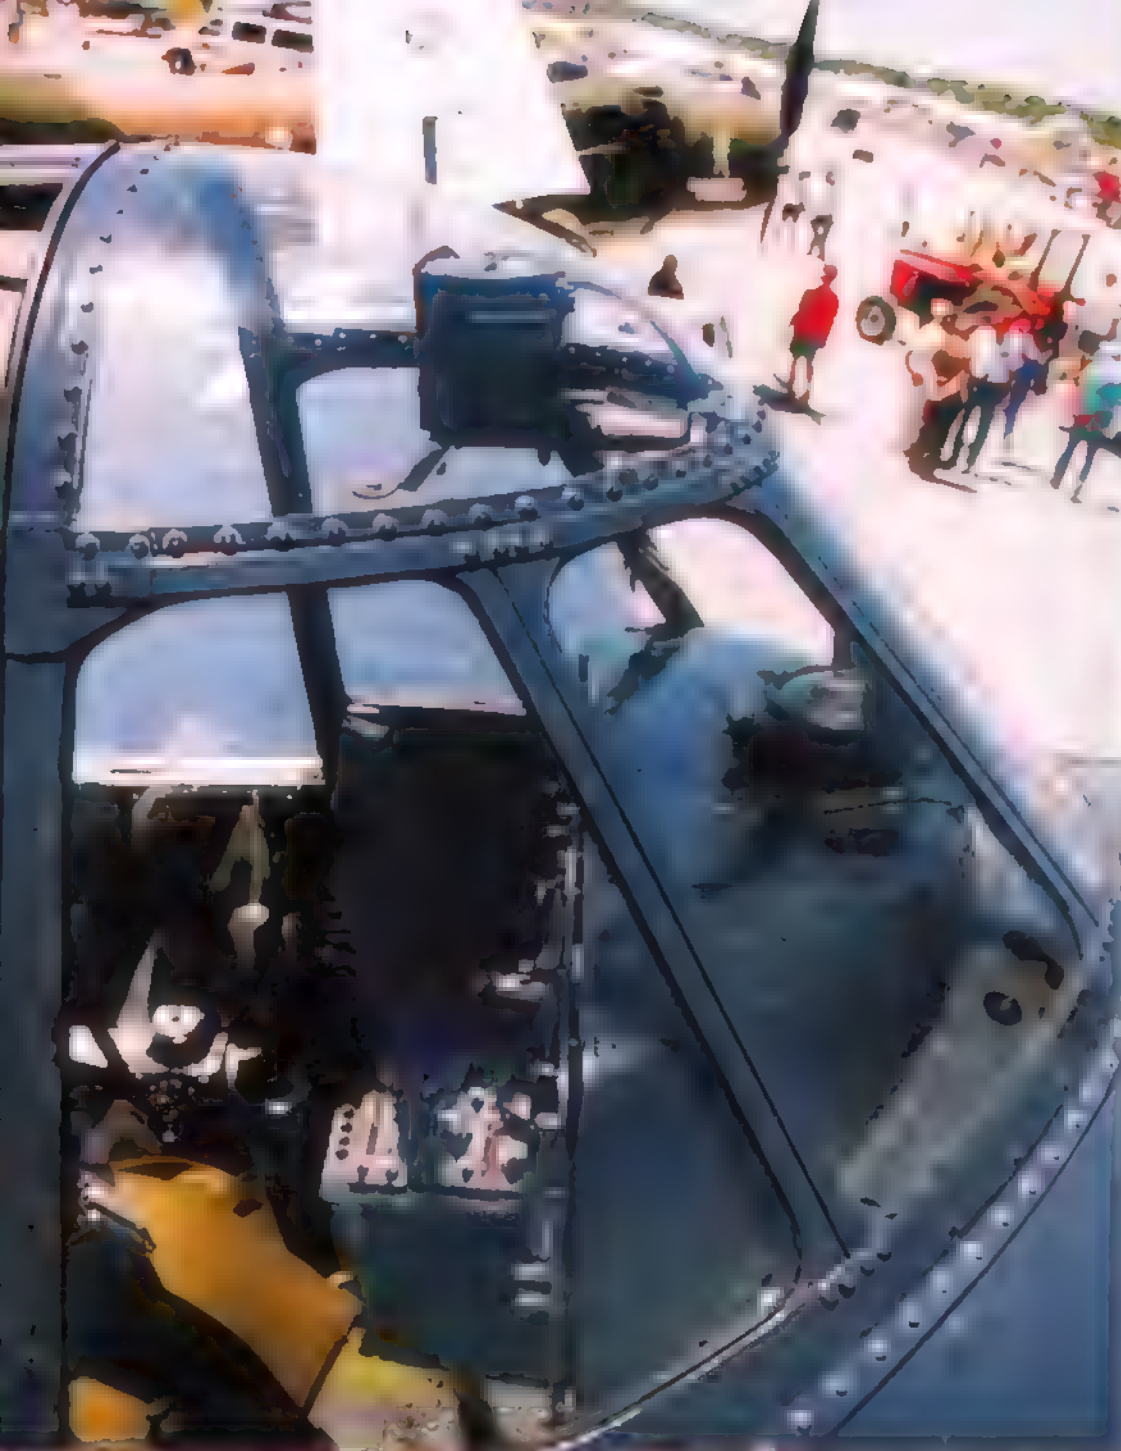
A Mark 8 reflector gunsight was mounted atop the instrument panel shroud under the TBM-3's windshield. This sight allowed pilots to line up aerial targets for the two wing-mounted .50 caliber (12.7mm) machine guns and for torpedo attacks. A magnetic compass was placed under the windshield's uppermost panel to allow accurate readings without undue interference by the aircraft's metal structure. (Lou Drendel)

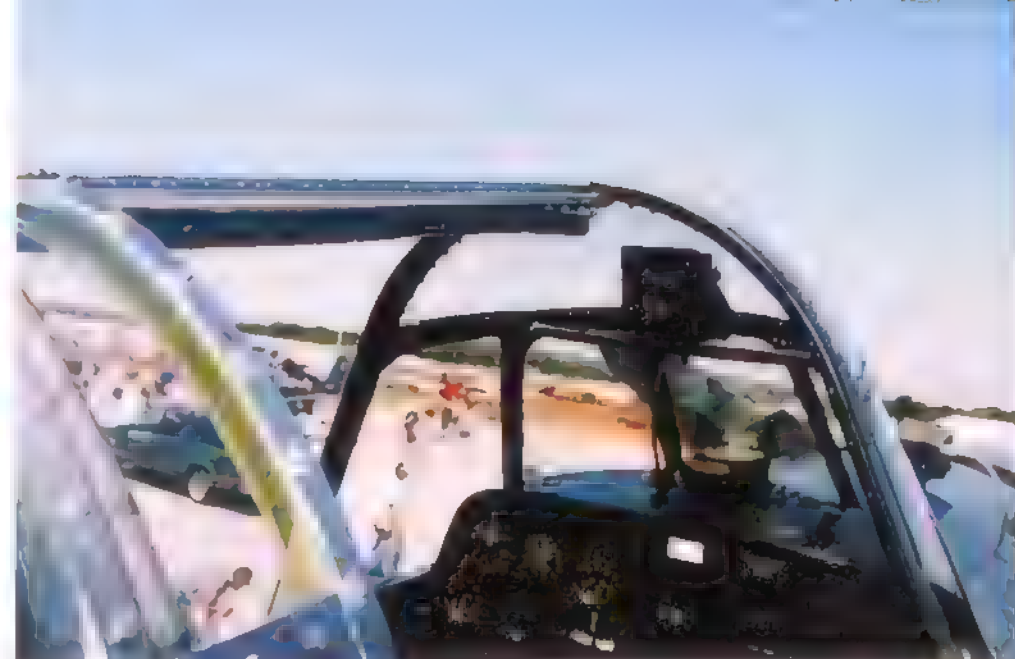
The pilot's canopy on all Avengers was split port and starboard. Either side canopy panel moved independently along the canopy center support. The panels were either locked closed, opened, or in one of three intermediate positions. Tan rubber seals were placed along the center support sides. These seals prevented water from falling into the cockpit through gaps in the canopy panels. (Lou Drendel)

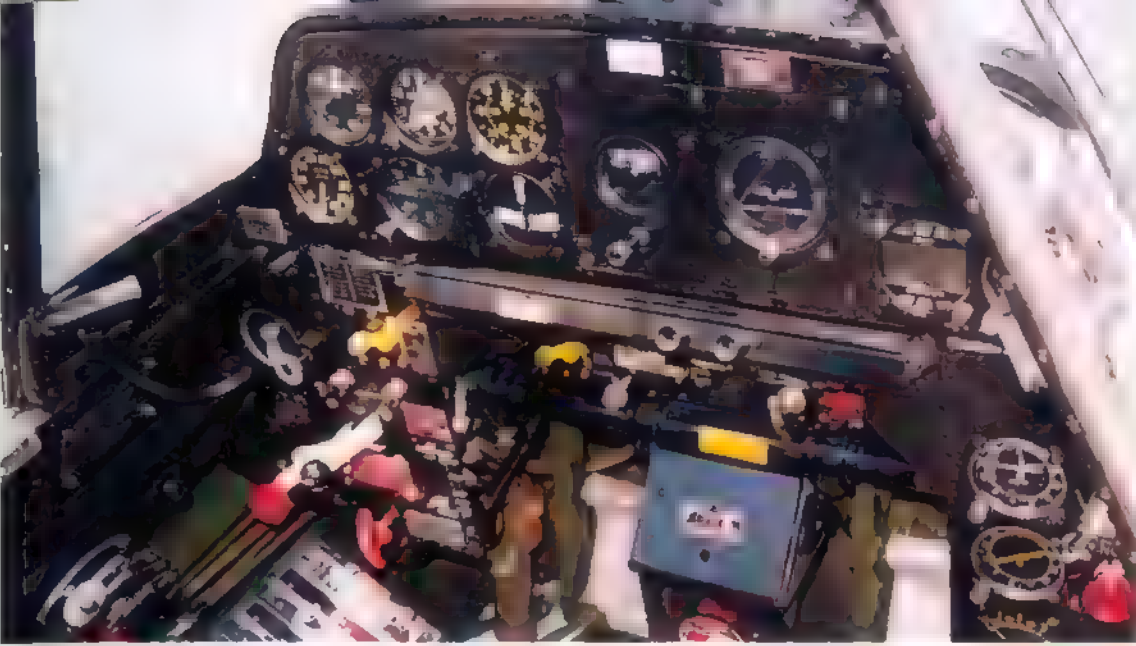
The TBM's landing gear and flap controls were placed in the lower left corner of the instrument panel. The long lever with a red square knob activated the landing gear, while the shorter lever with the black round knob operated the flaps. Some Avengers had the flaps and landing gear interconnected. The hydraulically operated landing gear took 15 seconds to retract and 12 seconds to extend. Modern navigation instruments were placed in this aircraft's starboard instrument panel. (Lou Drendel)

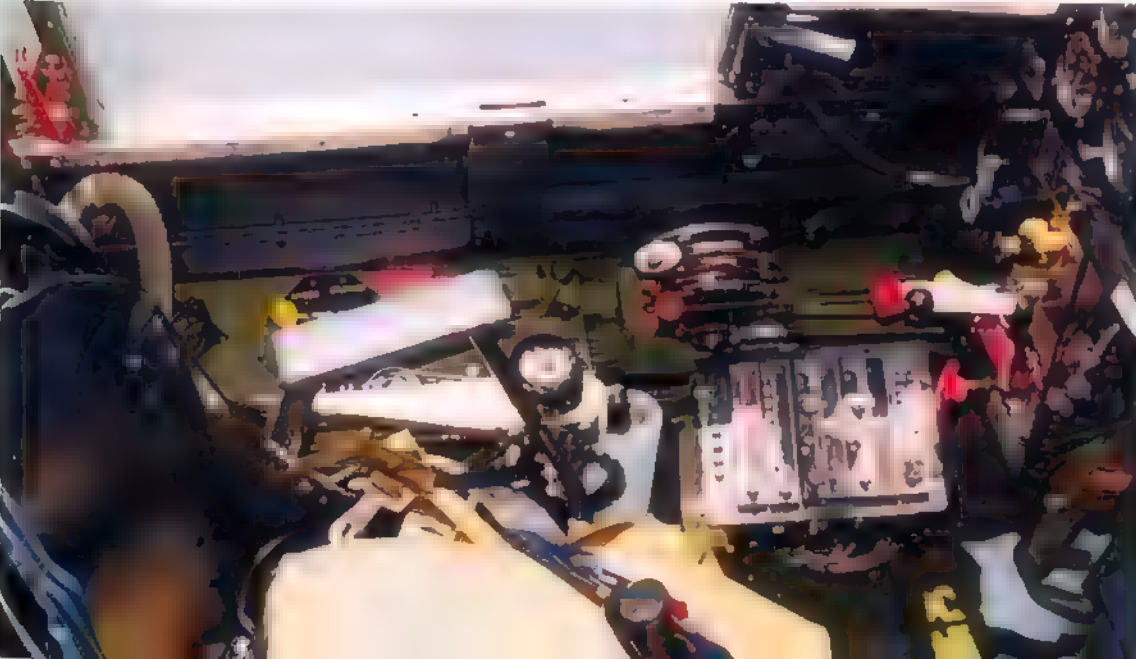
Modern avionics were placed in a radio stack immediately beneath the throttle quadrant of the Cavanaugh Flight Museum's TBM-3 Avenger. These avionics and the modern seat belts and cushion are the only items out of place in a wartime Avenger cockpit. The mixture lever for regulating the amount of fuel and air entering the engine was mounted inboard of the throttle. The basic interior color on Eastern-made TBMs was Interior Green (FS34151), while Grumman-built TBFs used Bronze Green (FS34058). The red item on the front of the control stick grip covered the trigger for the Avenger's two wing-mounted .50 caliber (12.7mm) machine guns. The red bottom on top of the grip was the pilot's radio 'talk' button, pressed when speaking into his throat-mounted microphone. (Lou Drendel)

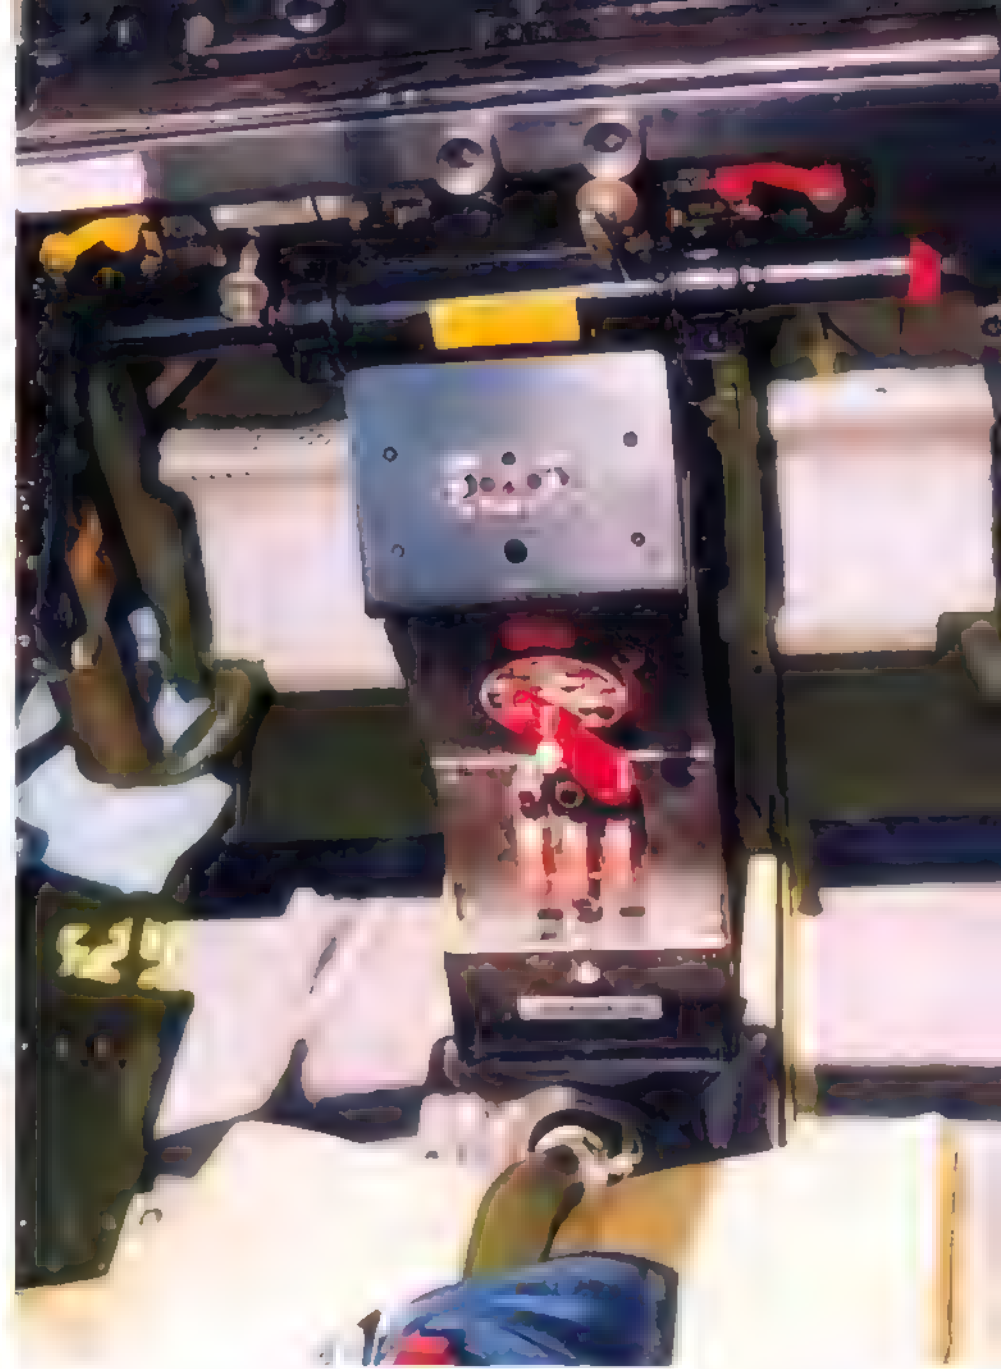
The TBM's center console controlled fuel flow from the aircraft's three main fuel tanks. The fuel tanks – under the cockpit and inside the inner wing sections – held 325 gallons (1230.3 L) of 100-octane gasoline. The three switches with red guards activated the fuel pumps and the larger red lever above selected the fuel tank to be used. The small panel on top of this console was a modern intercom system retrofitted to Cavanaugh's Avenger. The two rudder pedals flanked the center console on the cockpit floor. (Lou Drendel)

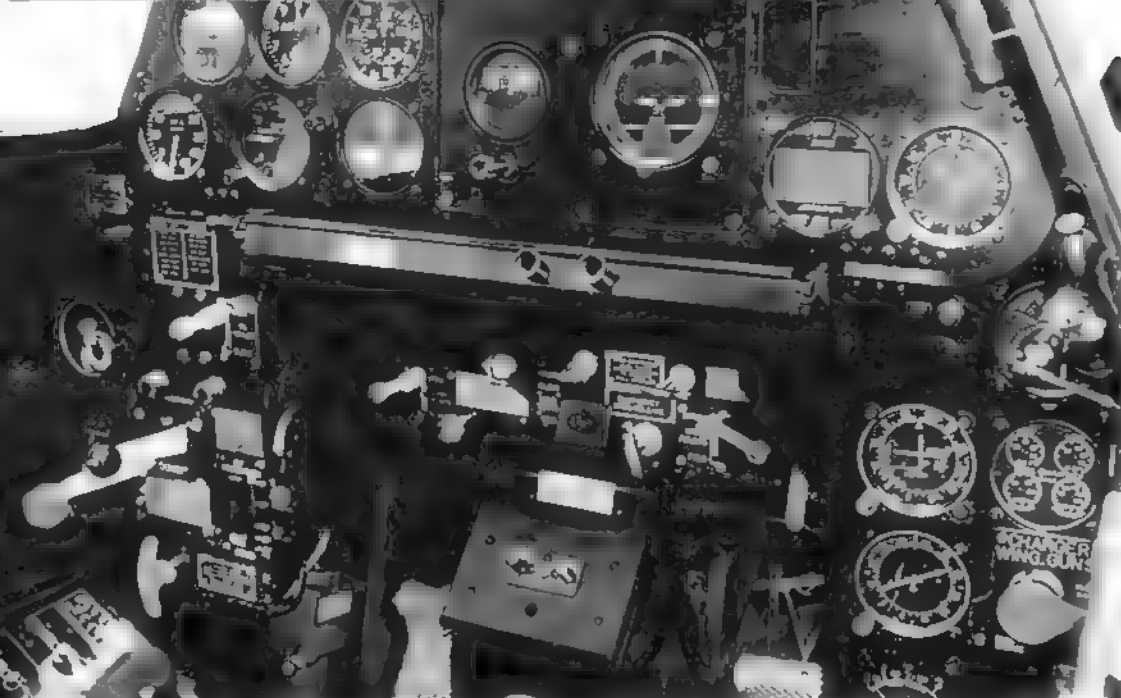
Several modern instruments were installed in the upper right instrument panel of the Cavanaugh Flight Museum's Avenger. Controls under the plotting board included the yellow cowl flap crank (port) and the red wing fold crank (starboard). The bomb bay door control was placed in the lower panel's center. (Lou Drendel)

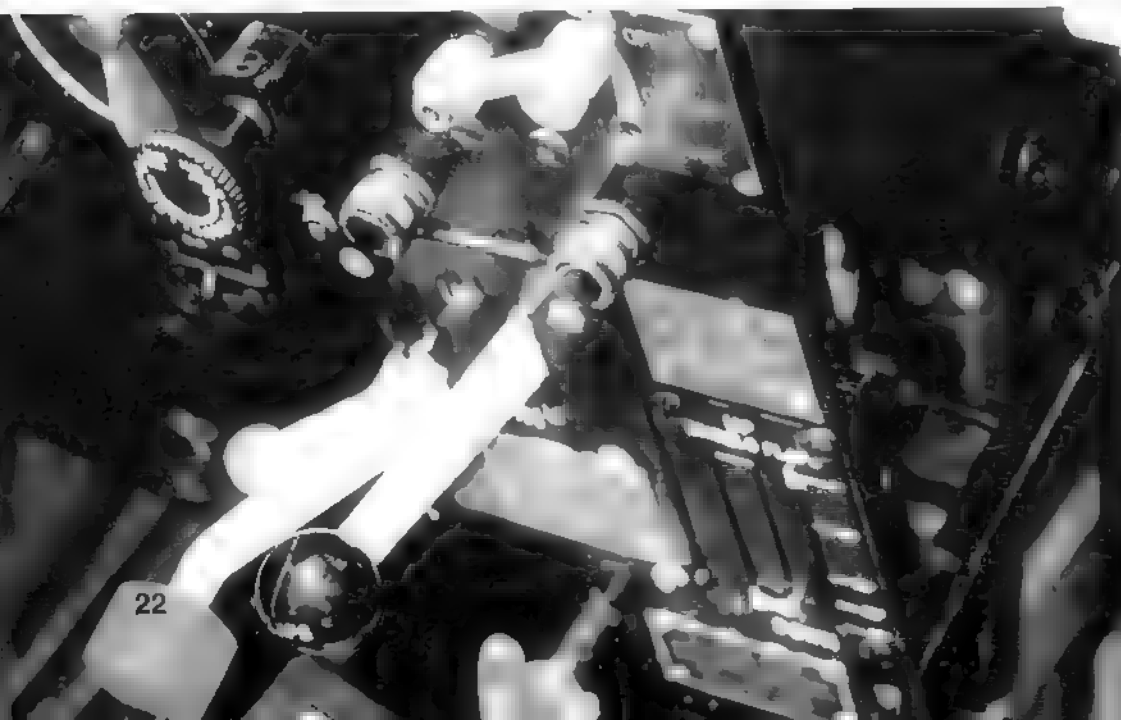
The flap and landing gear handles were placed on the TBM instrument panel's port side. The flap lever had a red square handle, while the landing gear lever used a black round handle. The size and shape of these handles allowed for easy recognition by the pilot in all lighting conditions. Mechanical position indicators for both levers were placed to starboard of these handles. (Lou Drendel)

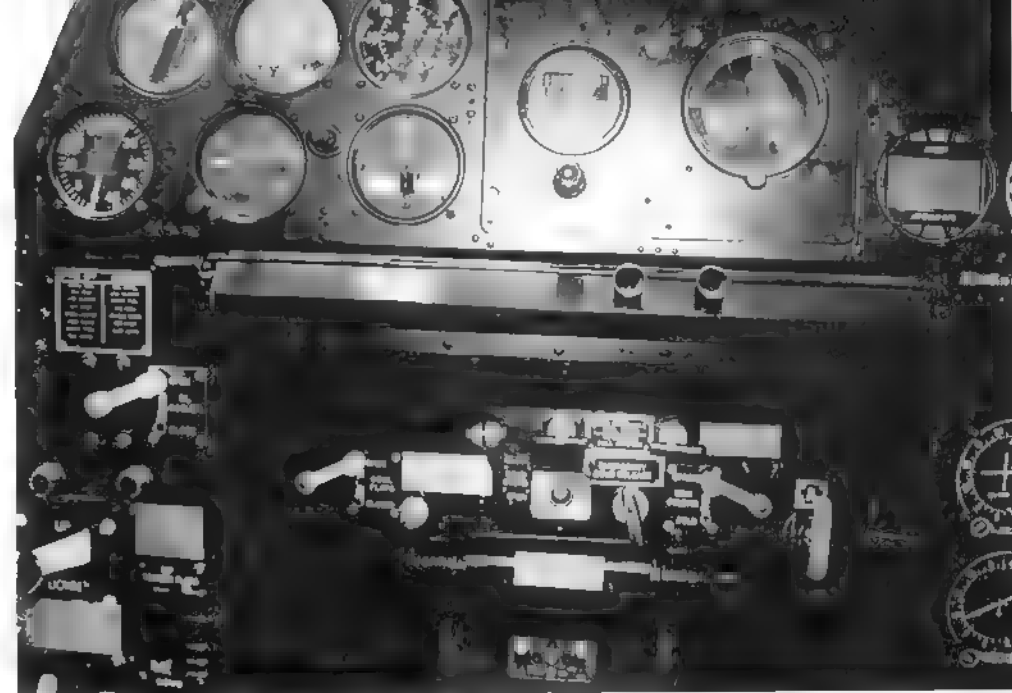
The Cavanaugh Avenger's panel contains many original instruments, with modern avionics displays confined to the starboard side of the panel. These included a GPS (Global Positioning System) receiver just above the right edge of the retracted plotting board. The Instrument Black (FS27038) panel color was authentic for US World War II-era military aircraft. (Lou Drendel)

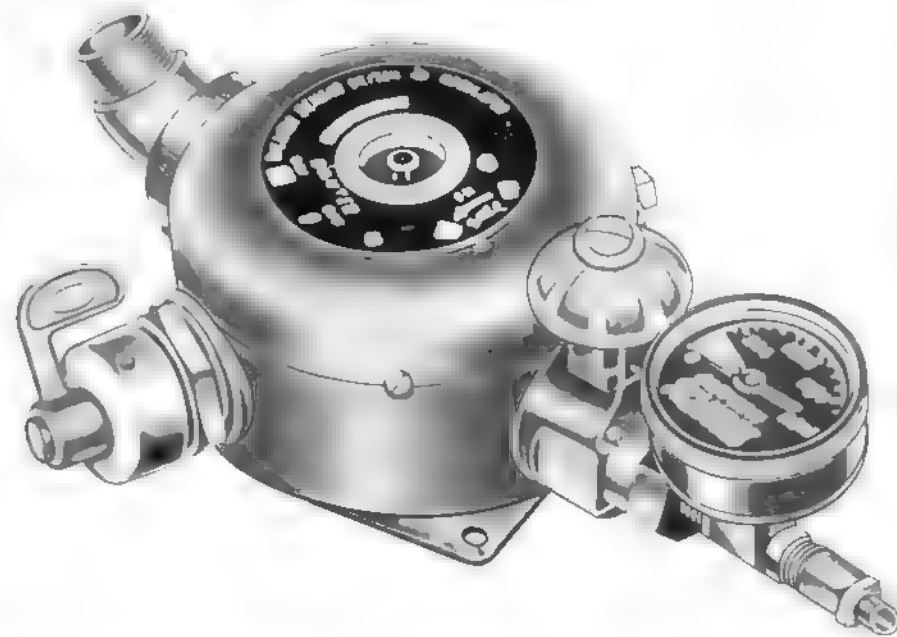
Oxygen Regulator (Placed Behind Pilot's Seat on Bulkhead)

The port cockpit console of Cavanaugh's TBM-3 was painted Interior Green (FS34151), while the cockpit walls were finished in Glossy Sea Blue (FS15042) – a non-standard finish. The hose beside the pilot's seat supplied oxygen for high altitude flights. The oxygen regulator fitted behind the pilot's seat controlled the oxygen flow to the pilot's face mask. Modern aviation radios were installed beside the throttle quadrant of this flyable Avenger. (Lou Drendel)
